# The 13<sup>th</sup> ISAV2023 International Conference on Acoustics and Vibration

## **Vibration Analysis for Fault Diagnosis in an Overflow Ball Mill: A Case Study at Sarcheshmeh Copper Complex**

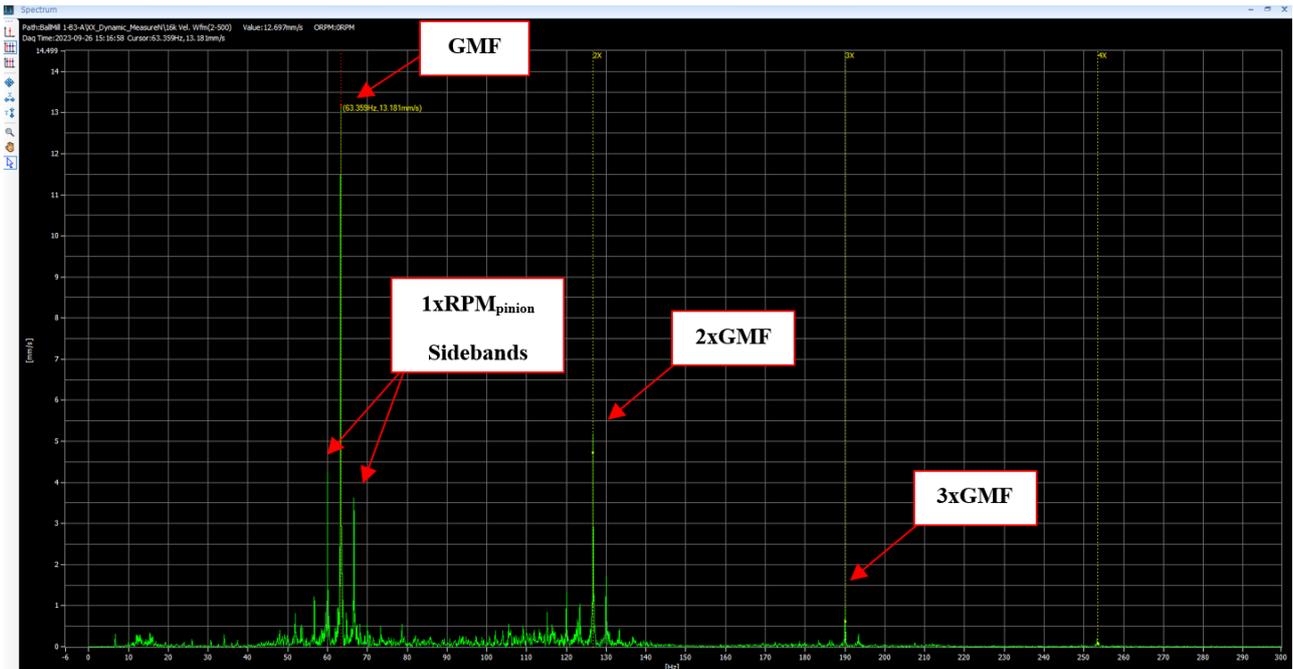
Figure 4. Bearing No.3 Frequency spectrum axial direction.

Analyzing the trend over a one-month period reveals variable amplitude vibrations observed in the axial direction of the first, third, and fourth bearings. Examining the axial direction of the frequency spectrum for bearing No.3 (see Fig. 4) and bearing No.4 (see Fig. 5) reveals that the dominant peaks are associated with gear mesh frequencies. Specifically, the 2xGMF frequency predominates in the axial direction of bearing No.4, whereas the 1xGMF frequency is the dominant peak in the axial direction of bearing No.3. Additionally, there are discernible 1xRPM and 2xRPM sidebands surrounding the 1xGMF and 2xGMF frequencies in the frequency spectrum of both bearing No.3 and No.4.

Upon analyzing the frequency spectrum of the third and fourth bearings, it becomes evident that the high amplitude of vibrations can be attributed to the gear mesh frequencies. These gear mesh frequencies ( $3xGMF$ ,  $2xGMF$ ,  $GMF$ ) consistently appear in the standard frequency spectrum with minimal amplitudes. However, any increase in the amplitude of these peaks or sidebands suggests the potential presence of an issue within the gear assembly, necessitating further investigation. The spectrum analysis of the third and fourth bearings has unveiled the existence of certain defects, listed below in order of priority.

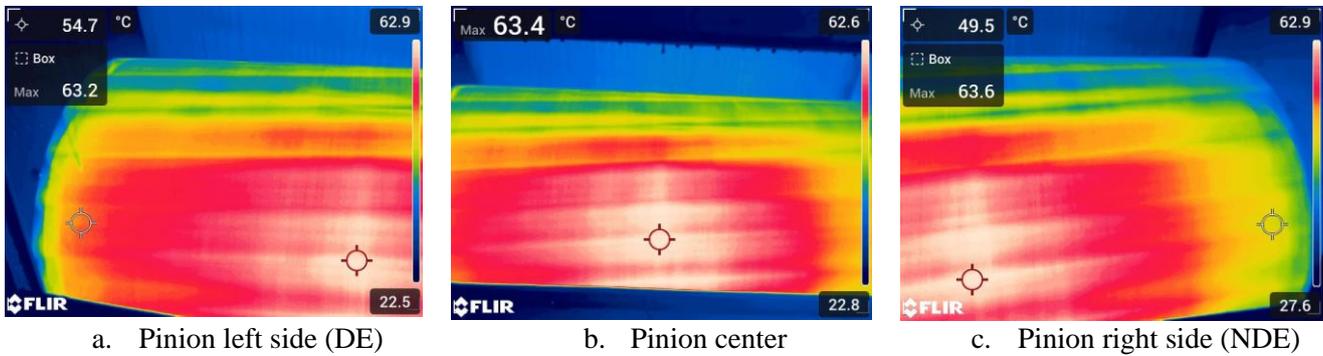
Figure 6. Thermal analysis of pinion surface.

To gain a more precise understanding of the issue, temperature analysis was performed using the FLIR TG500 thermal imaging camera, and the results are illustrated in Fig 6. As evident from the illustration, the temperature distribution across the pinion's surface is uneven. The region with the highest temperature, signifying the contact surface, tilts towards the left (the drive-end side). Specifically, the temperature on the left side measures 54.7 °C, whereas on the right side, it registers at 49.5 °C.

**Misalignment:** An increase in vibration amplitude at the  $2xGMF$  frequency, along with the presence of  $1xRPM$  and  $2xRPM$  sidebands, suggests the existence of a misalignment problem within the gears. This misalignment issue is further confirmed by examining the thermography images (Figure 6). The temperature distribution across the pinion surface is non-uniform, indicating that the contact area may not be symmetrical, which is a problem resulting from misalignment. Misalignment can manifest in various forms, as illustrated in Figure 8.

indicated by an uneven wear pattern on the tooth surfaces. As a recommended course of action, it is advisable to initiate a thorough cleaning of the tooth surfaces and subject them to visual inspection. Investigating the manner and location of wear on the tooth surface can be particularly effective in detecting misalignment and identifying its specific type, as elaborated in the analysis section.
