# The 13<sup>th</sup> ISAV2023 International Conference on Acoustics and Vibration

## **Vibration Analysis for Fault Diagnosis in an Overflow Ball Mill: A Case Study at Sarcheshmeh Copper Complex**

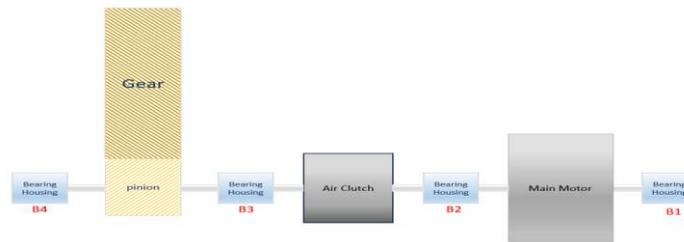
The condition of the ball mill is assessed by measuring vibrations on non-rotating components in accordance with the principles outlined in "ISO 10816". As per the standard, measurements are conducted on the four bearing pedestals, as illustrated in Figure 3. Vibration data is recorded in three distinct axes—vertical, horizontal, and axial—for all four bearing pedestals.

**Figure 1.** Data measuring points.

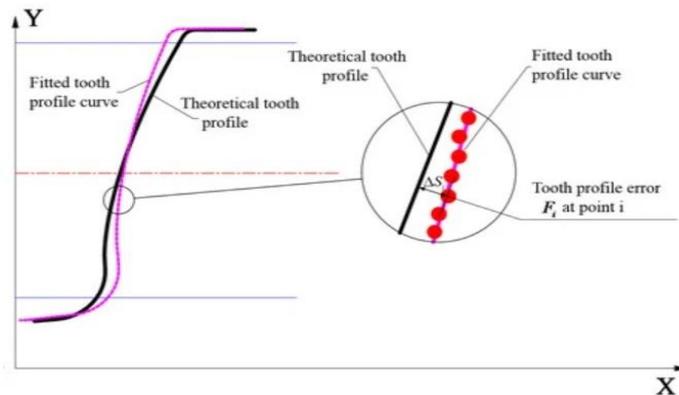
**Tooth Profile Error:** The presence of fluctuating vibrations in the gear and pinion system indicates the existence of a force with variable amplitude. One contributing factor to this variable amplitude force is errors in the tooth profile. A tooth profile error becomes problematic when the manufactured tooth profile deviates significantly from the ideal design state. As illustrated in Figure 7, the black profile represents the ideal and design state, while the purple profile depicts the actual manufactured profile. A tooth profile error can lead to issues such as incorrect backlash or gear meshing problems.

Figure 7. Tooth profile error.

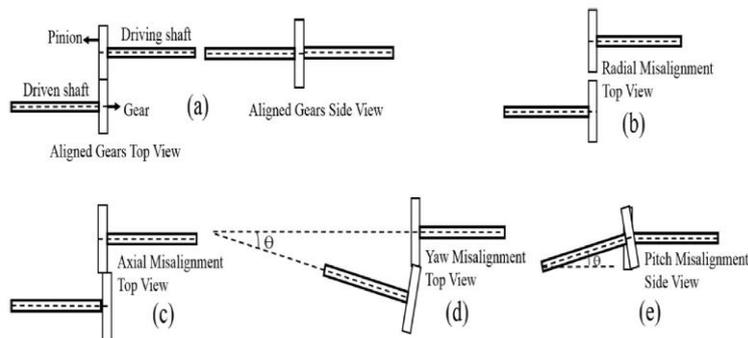
**Misalignment:** An increase in vibration amplitude at the  $2xGMF$  frequency, along with the presence of  $1xRPM$  and  $2xRPM$  sidebands, suggests the existence of a misalignment problem within the gears. This misalignment issue is further confirmed by examining the thermography images (Figure 6). The temperature distribution across the pinion surface is non-uniform, indicating that the contact area may not be symmetrical, which is a problem resulting from misalignment. Misalignment can manifest in various forms, as illustrated in Figure 8.

Figure 8. Five types of misalignment.

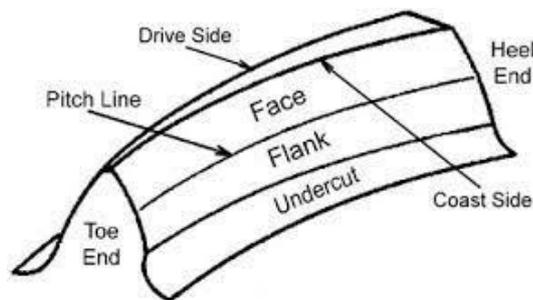
**Pitch Misalignment:** When the pinion and gear shafts are misaligned by introducing an angle in the vertical plane, pitch misalignment occurs. This type of misalignment leads to increased wear on the

flank edges, reducing the cushioning effect and causing the gears to impact and separate along the flank edges during meshing.

Figure 9. Flank zone in the tooth surface.
